York Archaeological Trust was commissioned by Arup to undertake an archaeological baseline assessment of the likely archaeological deposit sequence, and the history, descriptions and significance of the buildings and structures on the site of the proposed York Central Development Area (Figure 1). This was carried out during January and February 2018. The aim of this study is to provide a baseline of information to inform future planning proposals within this area.

An environmental noise and vibration survey has been undertaken to determine the existing conditions in and around the proposed Development. Measurements have been undertaken in accordance with national and international industry good practice guidance.

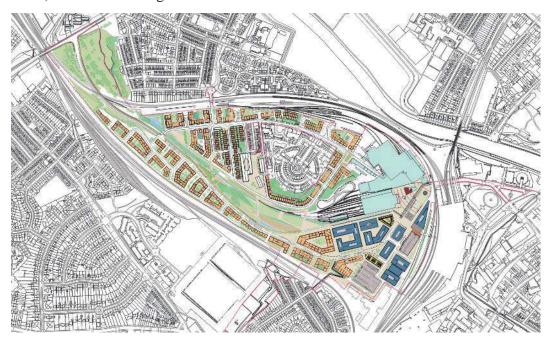
Figure 10B.1: Proposed Development, with boundary and surrounding area

As shown in Figure 10B.1, the proposed site is located immediately adjacent to York Railway Station, between the River Ouse and the A59 (Boroughbridge Road). The surrounding areas consist of both residential and commercial uses.

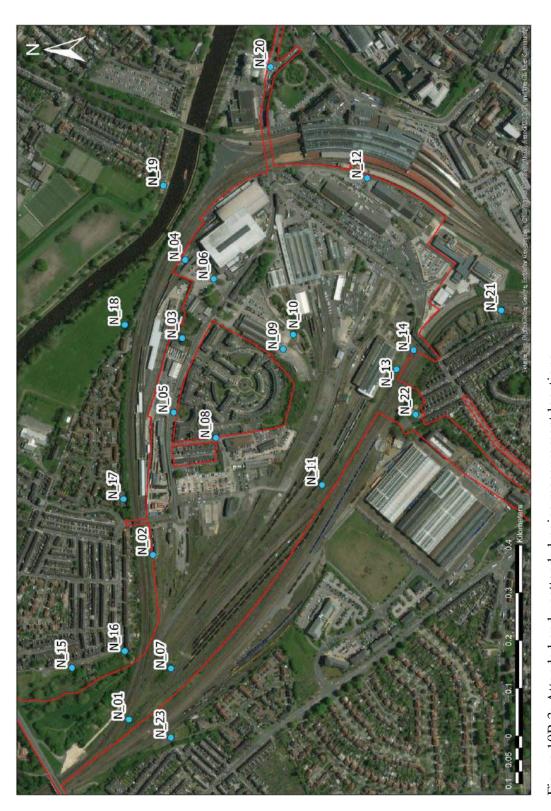
Figure 10B.3: Attended and unattended noise measurement locations

Unattended measurements were logged continuously for 5 minute periods during daytime, evening and night-time.

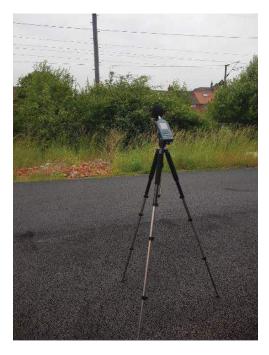
The acoustic environment was generally quiet, with the dominant noise being distant road traffic from Leeman Road as well as occasional train pass-bys and vehicle movement through the exit of the National Rail compound. The railway was ~22m from the measurement point, with the track raised above ground level.

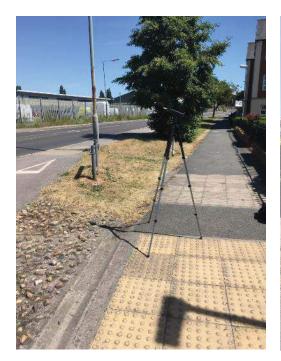
Figure 10B.11: N\_05 Location

The acoustic environment consisted of traffic on Leeman Road and passing pedestrians. ~2m from Leeman Road and 85m from closest railway.

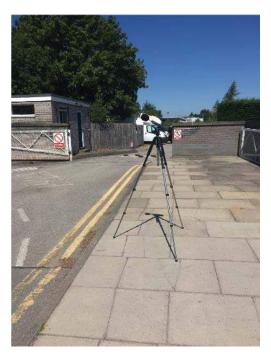
Figure 10B.13: N\_06 Location

The acoustic environment is dominated by road traffic on Leeman Road and the nearby car-park. The measurement location is around 40m from Leeman Road and 90m from the closest railway.

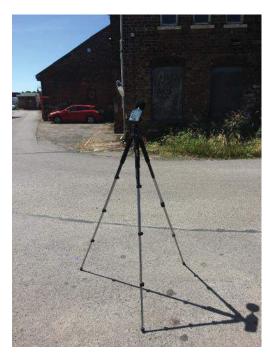
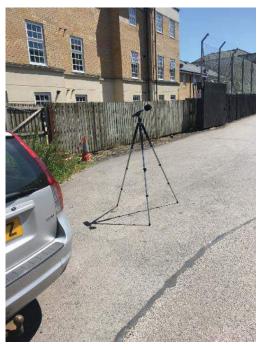
Figure 10B.15: N\_08 Location

The acoustic environment was quiet with occasional cars and vans passing by from the nearby car hire company and traffic audible from Leeman Road. ~100m from Leeman Road and 160m from closest railway.

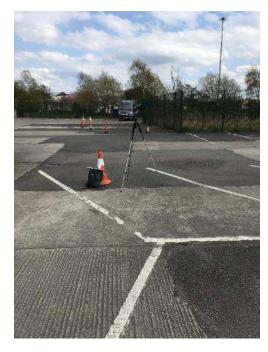
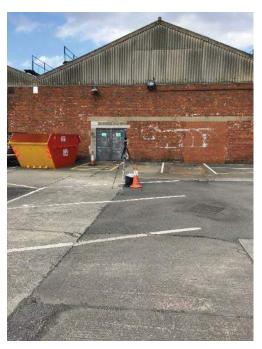
Figure 10B.3: N\_09 Location

The acoustic environment consisted of noise from children visiting the railway museum, cars in the visitor car park, coach engines running, and distant announcements from York station. The measurement location was ~30m from the ride-along train route and 60m from the East Coast Mainline.

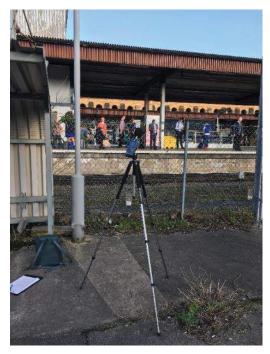
Figure 10B.5: N\_12 Location

The acoustic environment was dominated by heavy foot traffic from staff entering the National Rail buildings, with some noise from train passengers on the platform opposite. Around 25m from closest railway and 50m from station.

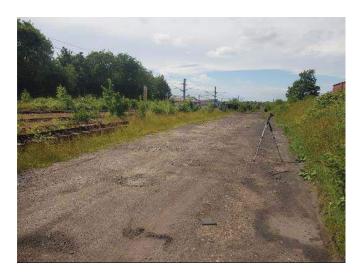
Figure 10B.7: N\_13 Location

The acoustic environment was quiet with no train activity on the nearest line throughout the duration of the measurement. There were distant sounds of children playing, lawn mowers and sirens. There was a gentle breeze but no strong gusts of wind.

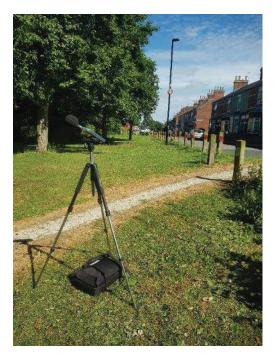
Figure 10B.10: N\_16 Location

The acoustic environment was generally quiet, consisting of distant road traffic from Water End, rustling of leaves and children playing in the distance with occasional train and car passes. During night-time, the dominant noise source was distant traffic from Water End and the A59, which was ~260m away. The railway was ~36m from the SLM and at a raised level. This measurement location is representative of the receptors along Garfield Terrace.

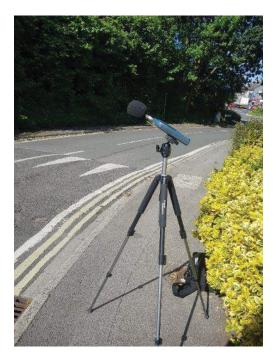
Figure 10B.12: N\_17 Location

The acoustic environment during the day consisted mainly of road traffic from Kingsland Terrace and Garfield Terrace (~30m away) and the rustling of leaves, as well as occasional train pass-bys. The measurement location was 17m from the railway and 6m from the nearest house. This measurement location is representative of the receptors along Aldborough Way the cul-de-sacs off it.

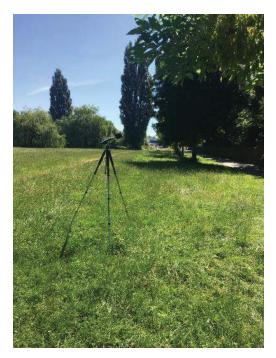
Figure 10B.14: N\_18 Location

The acoustic environment consisted of pedestrians and cyclists using the nearby footpath. The measurement location was 30m from the railway and 435m from Scarborough rail bridge. This measurement location is representative of the receptors on Aldborough Way.

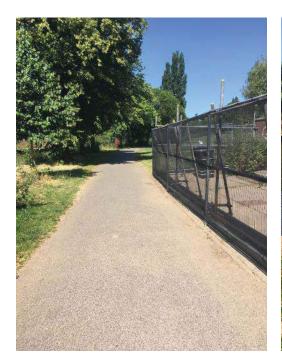
Figure 10B.16: N\_19 Location

The acoustic environment consisted of pedestrians and cyclists, with boats passing on the river. The measurement location was 80m from the railway and 130m from Scarborough rail bridge. This measurement location is representative of receptors on Almery Terrace.

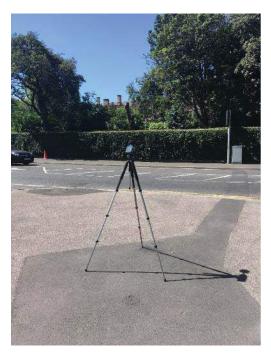
Figure 10B.18: N\_20 Location

The acoustic environment was dominated by traffic on Leeman Road, with a constant source of background noise from sightseeing buses in the nearby layby. ~6m from the BAS Remaps premises and 140m from the closest rail line.

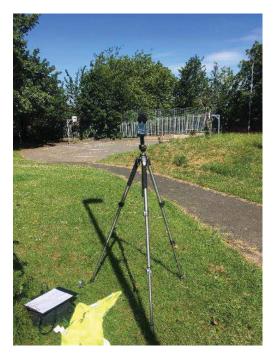
Figure 10B.22: N\_22 Location

The acoustic environment contained light birdsong during the day and industrial sounds from York Station (100m away). Distant road traffic was audible and there were intermittent loud clangs emanating from the Network Rail depot (~70m). The night-time environment contained no industrial noise or birdsong, but very distant road traffic from the A59, occasional seagulls and wind blowing through trees. The railway was ~45m away from the measurement position. This measurement location is representative of the receptors along Cleveland Street and Upper St Paul's Terrace.

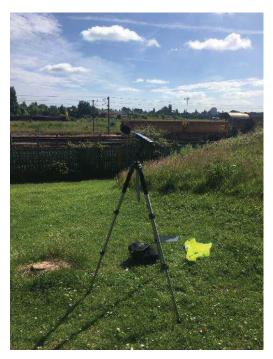
Figure 10B.24: N\_23 Location

The acoustic environment during the day was mainly birdsong with distant traffic on 'Water End' off the A59, ~250m away. There were occasional train passes and gusts of wind. The measurement location was 13m from the closest freight line and 30m from the mainline. The measurement location is representative of the receptors at Poplar Street, Renshaw Gardens and cul-desacs.

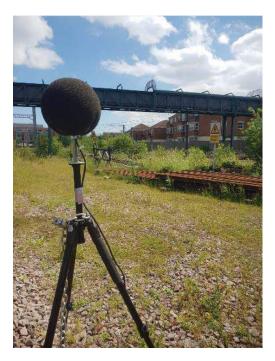
The acoustic environment was generally quiet, with the occasional train passes causing a large rise is noise level. Traffic from Leeman Road was barely audible. Some noise from the car park nearby could be heard. The measurement location was 25m form the nearest freight line and ~150m from two station/National Rail car parks.

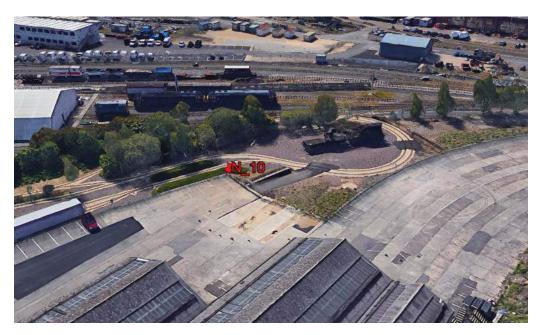
Figure 10B.37: N\_10 Location Copyright Google Earth Pro

The acoustic environment was dominated by sounds from the railway museum and trains coming into York station. There was some background noise from nearby Leeman Road.

The logger was recording between 17/04/2018 16:01 and 30/04/2018 13:36.

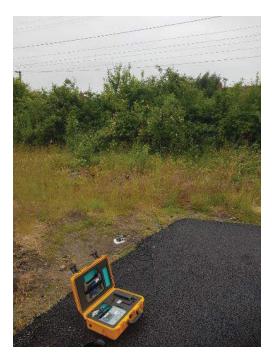
## $V_02$

The vibration environment consisted of occasional movements along the Network Rail compound exit route (63m away) towards Leeman Road, and the rail line 17m away.

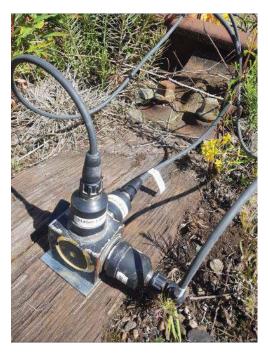
## $V_01$

The vibration environment consisted of occasional trains along the ECML (18m away), FAL in the +x and -x direction (40m away). The logger was recording between 18/06/2018 15:31 and 21/06/2018 17:10

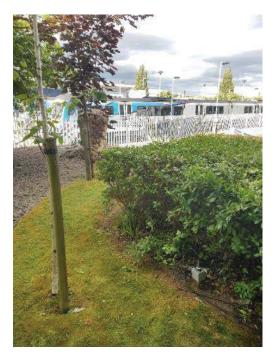
## $V_03$

The vibration environment consisted of trains idling on the maintenance depot 11m away and the East Coast Mainline 70m away. The traffic along Leeman Road, 40m away, also contributed to the measurements. The logger was recording between 20/06/2018 16:43 and 23/06/2018 18:45

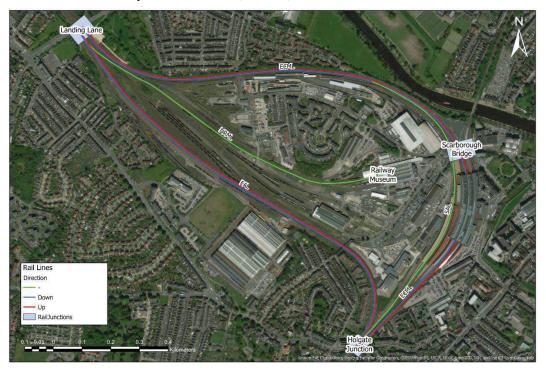
- East Coast main line (ECML)
- Freight avoiding line (FAL)
- Station avoiding line (SAL)
- National Railway Museum line (NRML)

Figure 10E.2: Simplified rail lines surrounding the proposed Development

For the purposes of this assessment, the following track names will be used, as shown in Figure 10E.2:

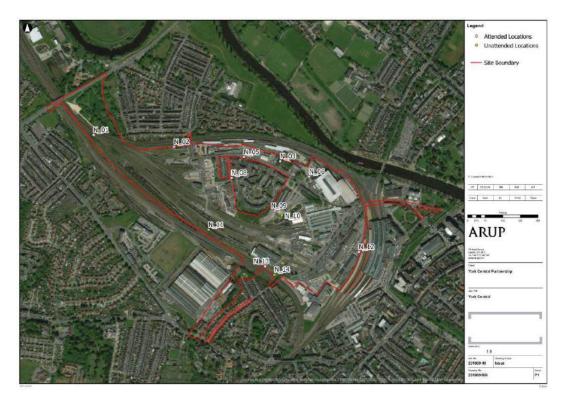
Figure 10E.3: Site layout and noise measurement locations

Noise measurement locations are reproduced in Figure 10E.3. A summary of measured noise levels are presented in Table 10E.6 – Table 10E.11.

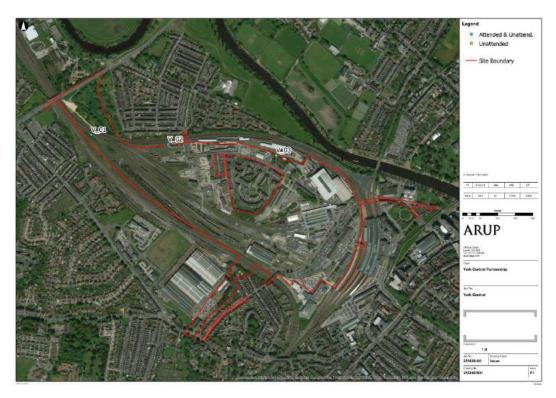
Figure 10E4: Site layout and vibration measurement locations

Vibration measurement locations are reproduced in Figure 10E4. A summary of measured vibration levels are presented in Table 10E.12.

Table 10E.12: Summary of measured vibration levels (see Figure 10E4)

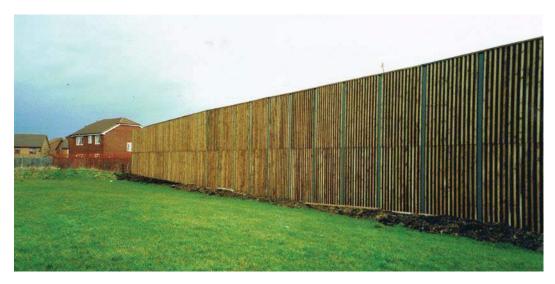
Figure 10E.7: Timber fence noise barrier

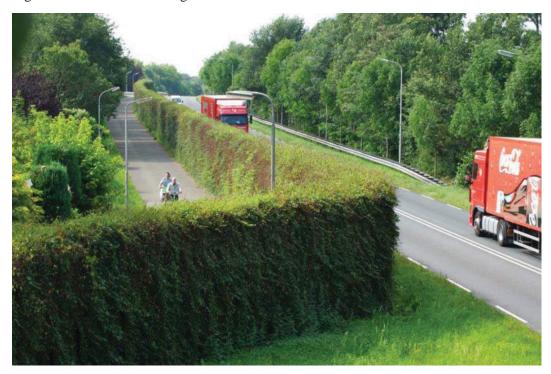
Figure 10E.9: Planted noise barrier

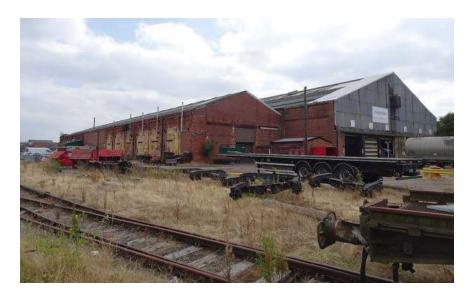
Plate 1. B18a Freightline depot

Two large buildings of old brick and some corrugated metal sheeting with extensive foraging habitat immediately available nearby.

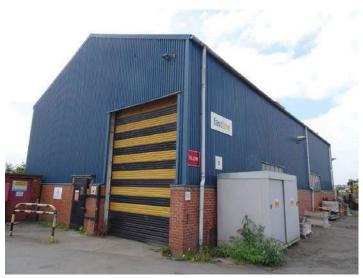
Plate 2. B34/B35

Unlikely to provide nesting opportunities but could be used as song posts.

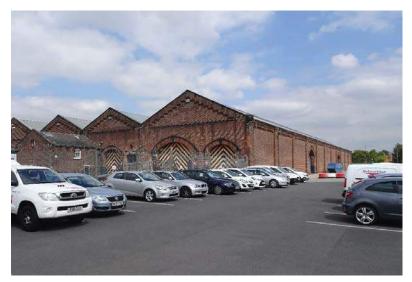
Appeared well-sealed and lacked obvious external features to provide nest sites, but could be used as song posts.

Plate 3. B7 brick-built industrial buildings

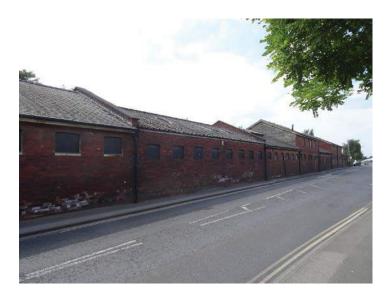
Plate 4. B36 old brick-built buildings

A missing dormer window in the roof would provide egress and this building is perhaps one of the better potential nesting sites.

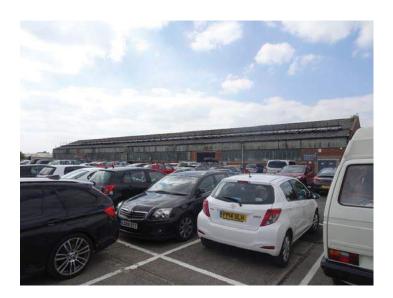
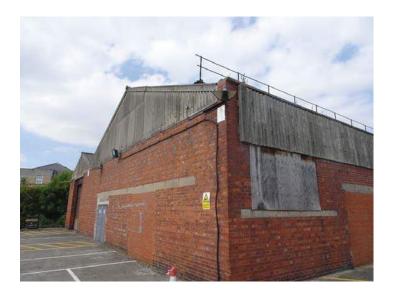
A female house sparrow was seen entering a hole in the side of this building and it is perhaps another of the better potential nesting sites.

Plate 5. B37 brick/ corrugated steel buildings

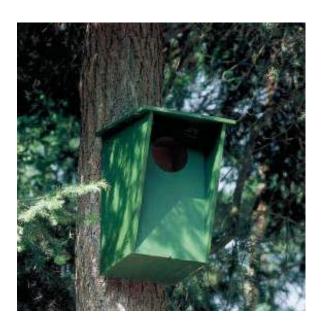
Stock dove will readily use nest boxes including the one below from CJ Wildlife (Plate 3). The box may also attract other species, including jackdaw and tawny owl, which although not recorded during the surveys, may utilise the site periodically.

Plate 3. Wooden box suitable for stock dove

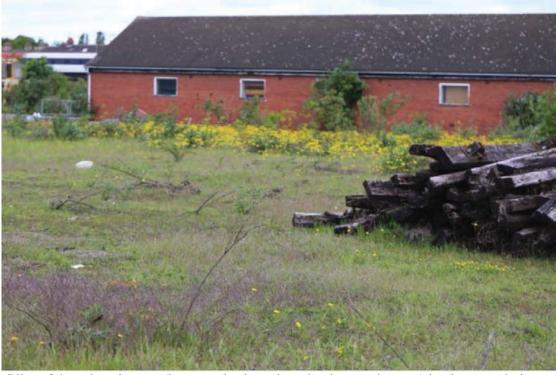
Piles of decaying sleepers (home to deadwood nesting bees and wasps) in close proximity to good flowering resources

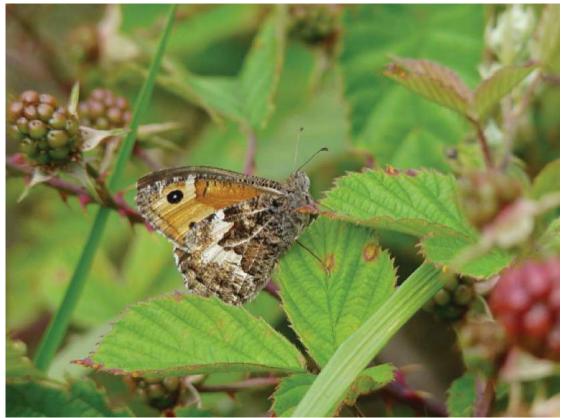
York Central Station 26

Grayling butterfly
